# Watching Brief and Excavation at The Church of The Holy Fathers of Nicea, formerly known as The Church of St. John.

Oteley Rd, Sutton, Shrewsbury, Shropshire.

Interim Report by J. Green

January 2018.

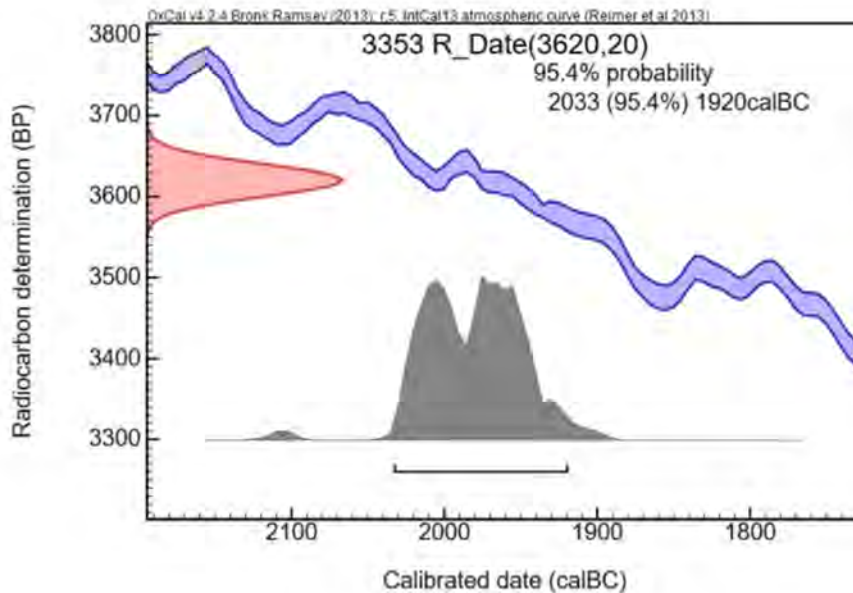
Figure. 5 Radio Carbon dating calibrated plot

Sample laboratory code	3353
Benzene mass	2,7421g
Counting time	3200 minutes
Sample count rate	16.583 CPM
Background count rate	0.583 CPM
Counting efficiency	73.61%
<b>Radiocarbon date</b>	<b>3620 ± 20 BP</b>
<b>Calibrated date (95.4% probability)</b>	<b>2033BC to 1920BC</b>

A posthole [1023] containing two Oak split timbers (1025) (1035) was excavated in the north corner of the trench. Radio carbon dates show these to be late Neolithic/early bronze age – 2033 BC. A deposit measuring 1m by 2m provided evidence of burning extending to the northern edge of the trench at this point (1029). This deposit was not fully excavated due to time constraints but approximately 0.50m in depth. It is possible it could be a hearth or an incident of accidental fire damage to an earlier thatched roof. Given the date of the adjacent wooden posts it is also extremely likely that this area could be connected to prehistoric activity.

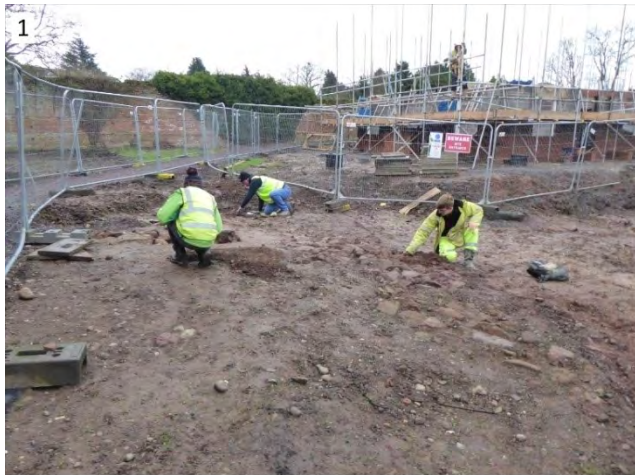
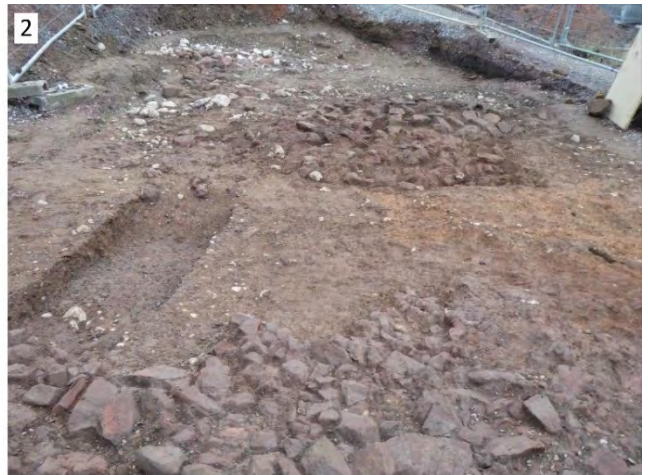
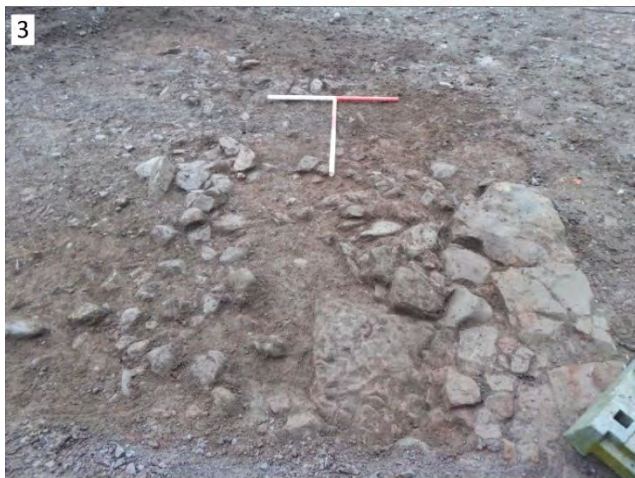
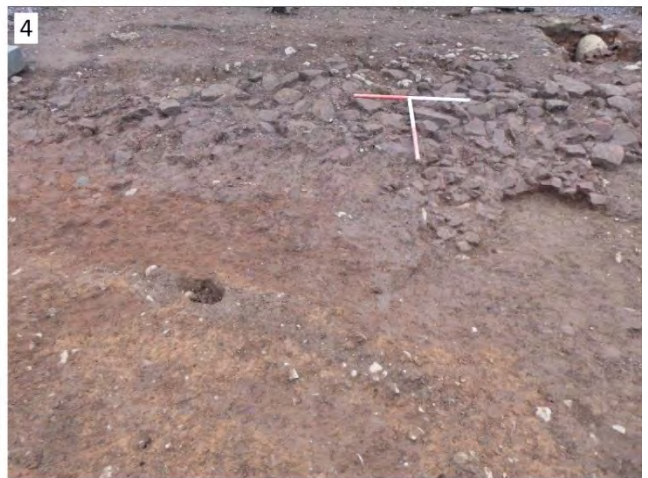
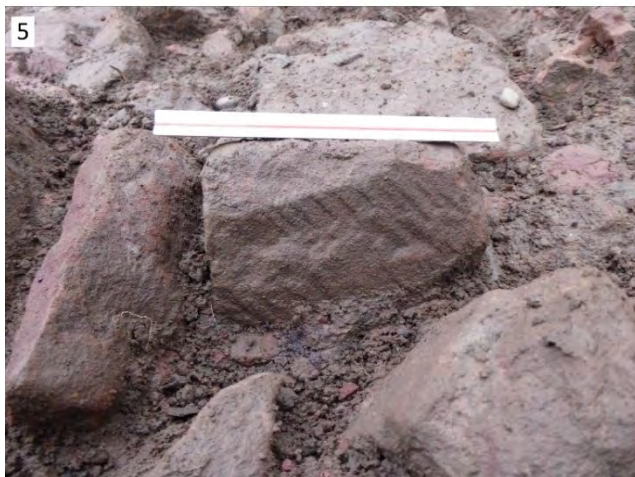
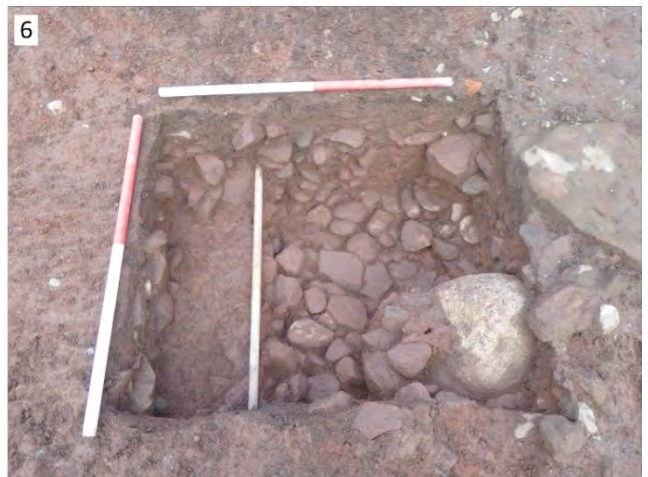
Plate.1 Working shot Area A, Trench 1, Bay 1. Facing South  
 Plate 2 Foundations (1003) (1004) Bay 1. Facing West  
 Plate 3 Foundations of bays 2 & 3 looking West. Return wall 1 in foreground  
 Plate 4 Return wall 2, floor area (1037) cut by land drain. Facing East  
 Plate 5 Example of dressed stone tool marks in return wall 1  
 Plate 6 Sondage B [1008] (1005) (1006) (1011) Foundations Extending West. Bay 1

This comprised an area of archaeological foundation deposits (1003) (1039), directly in front of the current Church doorway on the West wall. These corresponded with the existing footprint and run East West from both the North and South walls, to a return wall (1012), aligned North South 4m from the Church. This wall is 1.2m in width with varying levels of collapse (1013) above and adjacent to it (1019). Previous Geophysical results had identified an anomaly in this vicinity, (Stratascan, 2010), although it appeared from the imaging results to be continuing in a Southerly direction, it is likely that what was identified was part of this wall, and an electric cable subsequently discovered on precisely this alignment and position, during this excavation.

The stones are predominantly of red sandstone, with the occasional Grinshill stone. A number of the stones in this return wall are 'dressed' (1036) having tool marks visible to the face. The foundation stones form a clear edge to the Eastern side, the Western edge obscured with rubble, indicating that it likely collapsed Westerly. This would be a logical conclusion to draw as the ground slopes naturally in this direction. Within this first bay there lies a cobbled surface (1020), which is heavily disturbed by modern activity but remains in patches. This was likely a simple floor to serve an earlier entranceway. Also identified were 3 postholes cut into this floor area. One of which was excavated [1030] and interpreted as modern, likely connected to a previous metal railing fence in front of the Church.

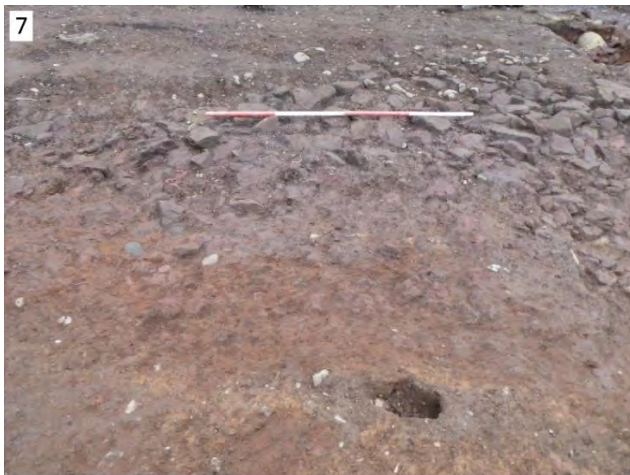
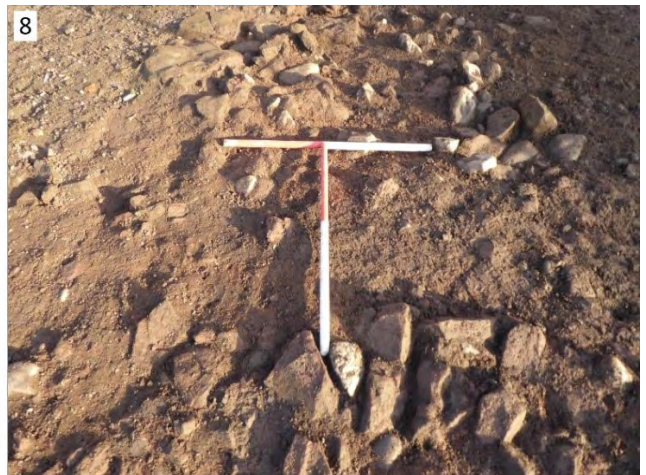
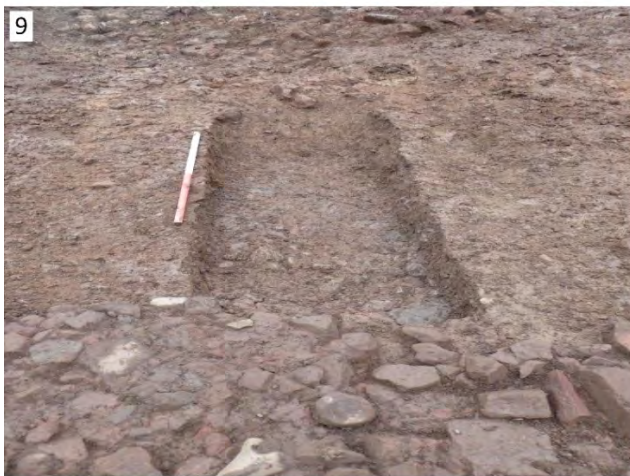
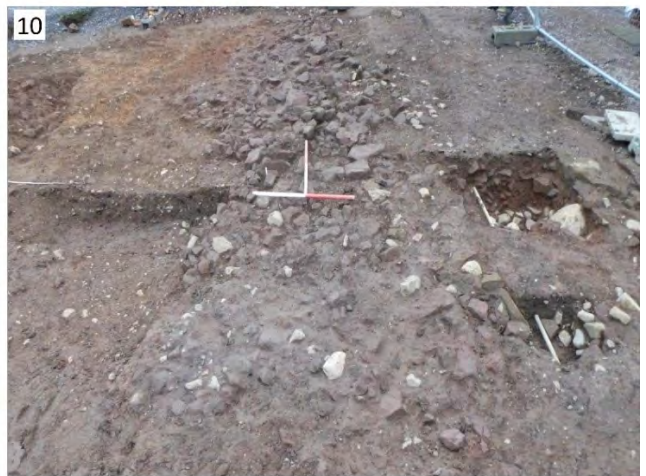
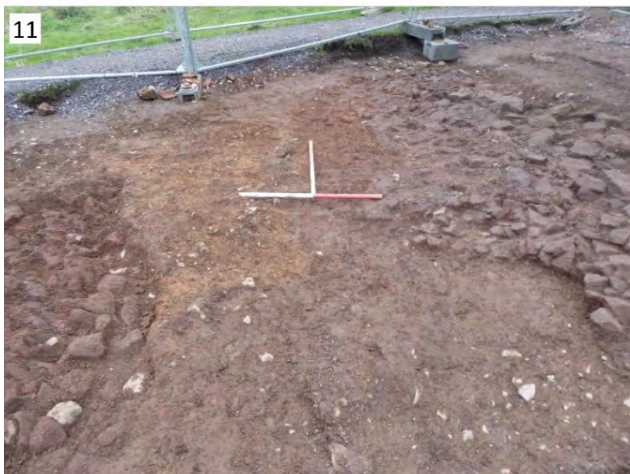
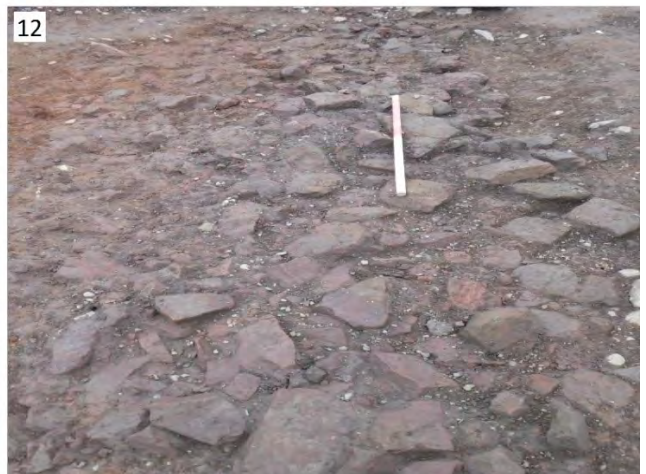
Plate. 7 Return wall 2 (1038) and possible floor area (1037). Facing East  
Plate. 8 Cut of Electric Cable [1008] between Foundation (1039) and rubble deposits (1004) Facing South. Pre-excavation

Plate. 9 Slot Through Robbed Trench [1014]. Facing West  
Plate. 10 Sondage's a & b, Return wall 1 (1012) and (1032) (1033). Facing North  
Plate. 11 Return Walls 1 & 2, With Central Floor Deposit (1037). Facing North  
Plate. 12 Return wall 1 (1032). Facing North

The South foundation wall continued in a Westerly direction (1039), although ephemeral in places where stone had been removed at some earlier point in time. Deeper excavation at this point revealed a likely 'robber trench' [1014]. The stone wall remained at a deeper level (1027). A return wall (1021) (1038) again aligned North South divided the walls in to a second room/bay of approximately 3.6m. Exact dimensions were not ascertained due to the high level of collapsed rubble and obscuring clear edges and time constrained excavation. However, this area was covered with a sandy silt/ puddled clay (1037), within which were numerous large fragments of glazed medieval tile <1008>, suggesting a floor surface which had subsequently been removed. This floor area was approximately 7m north to south and was uncovered for approximately 4m east to west, to the limits of excavation. This area was cut by a modern land drain [1017] aligned north east/south west.

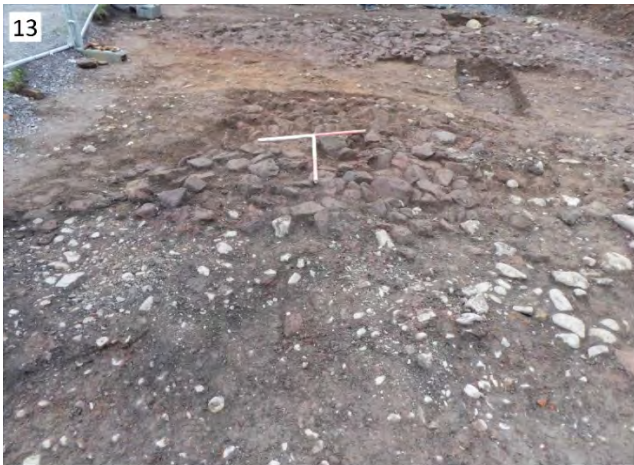
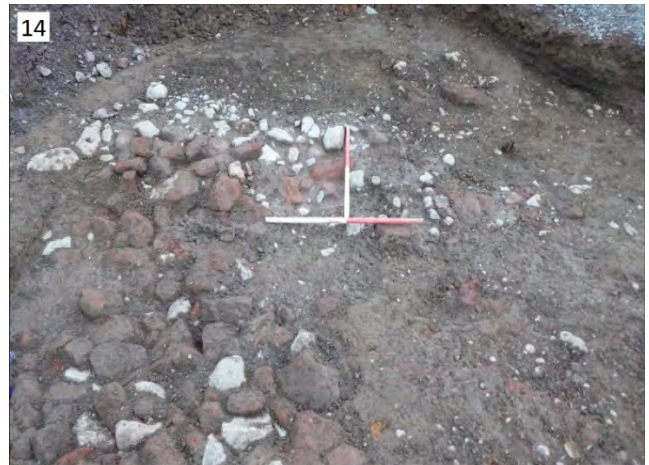
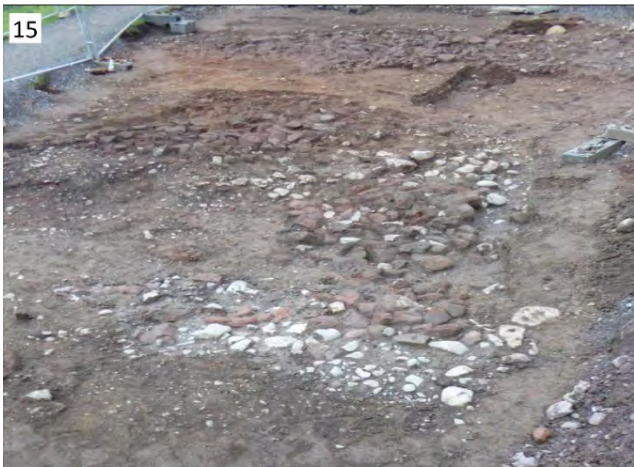
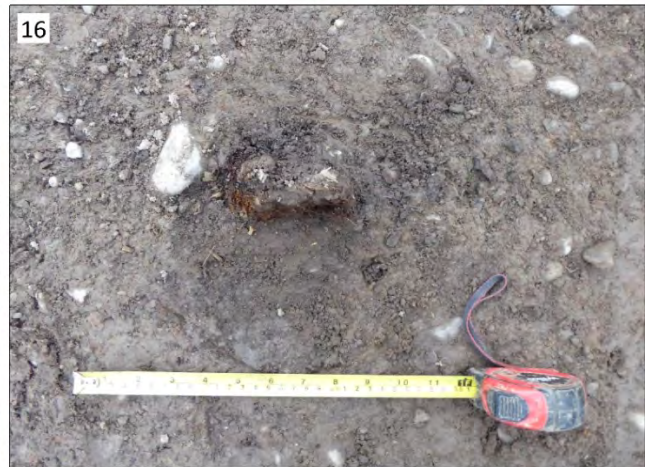
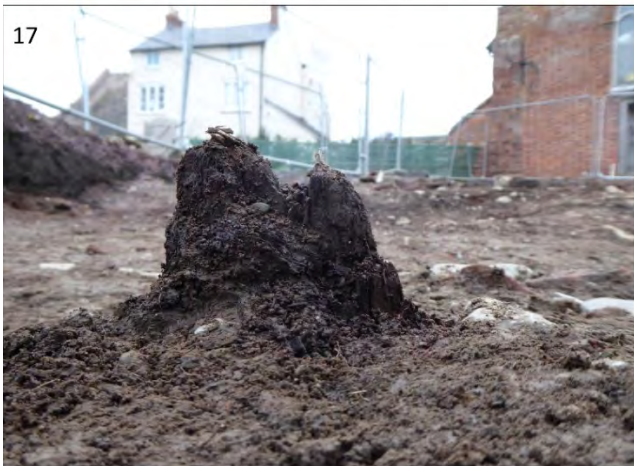
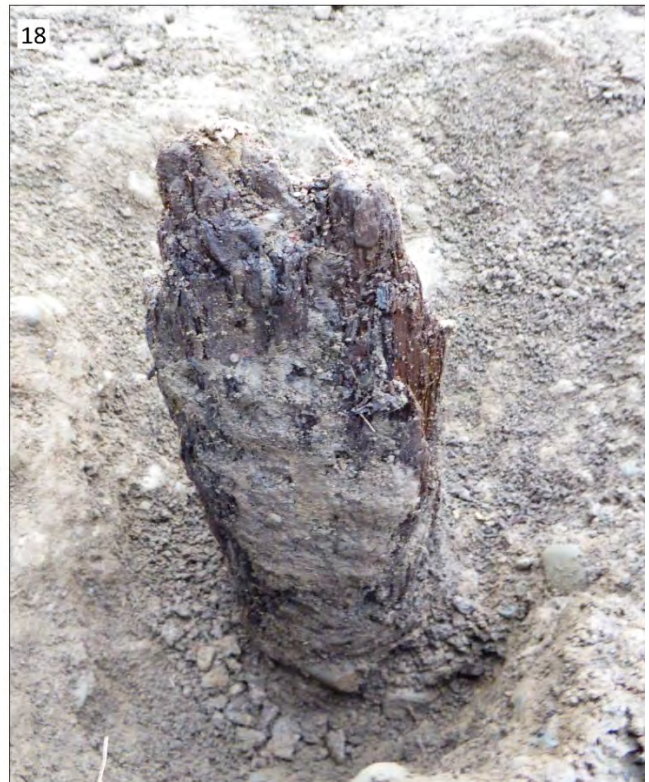
Plate 13 Return Walls 1 & 2, Facing East. Robbed trench [1014] and Prehistoric Area in Foreground (1034)

Plate 14 Wall (1039) Cobbles (1041) Return Wall 3 and Prehistoric Area, Oak Post in-situ (1025). Facing West

Plate 15 Trench 1 Post Excavation. Facing North  
 Plate 16 Prehistoric Post (1025) [1023] (1024) Pre-excavation  
 Plate 17 Prehistoric Post in situ pre-excavation  
 Plate 18 Prehistoric post in situ post excavation

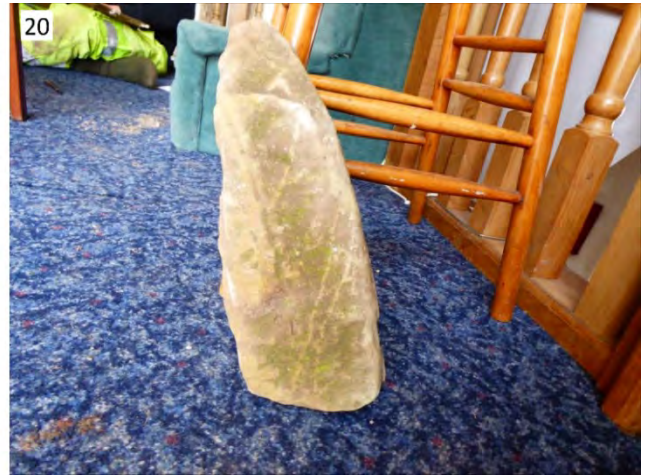
*Plate 20 Carved stone from archway found in bay 2/3.*

Amongst the rubble collapse between bays 2 and 3, a curved worked stone was recovered. This has mortar adhered to the outer edge and worn carvings to the face and represents part of an archway. This is a lighter colour than any of the stone in the current Church and is likely to be from a much earlier phase. This find could potentially date to Saxon/early Medieval.

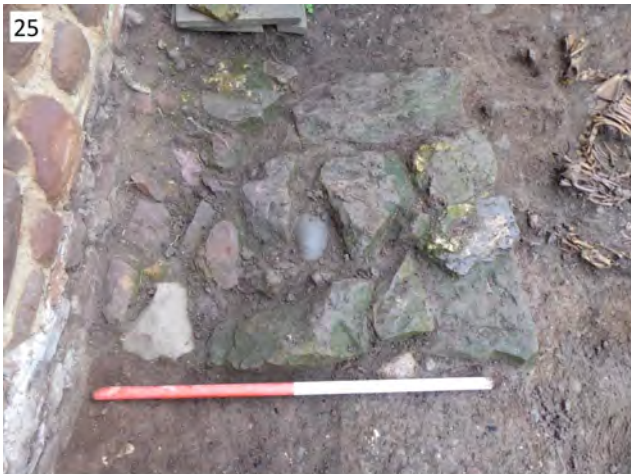
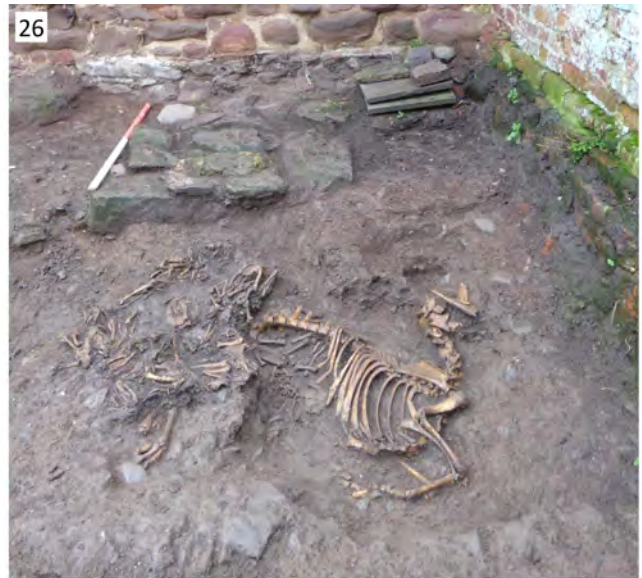
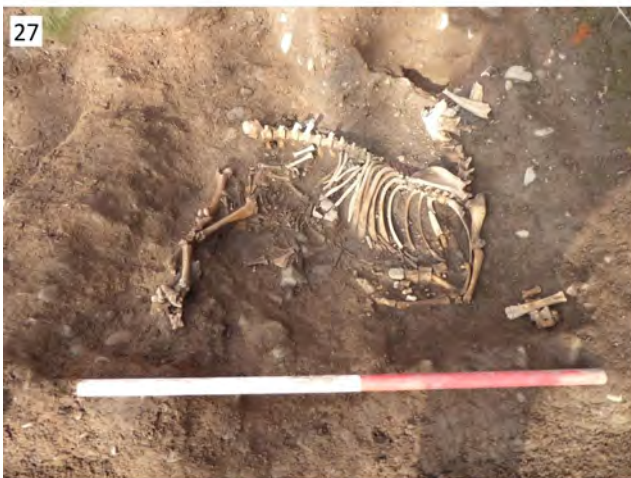
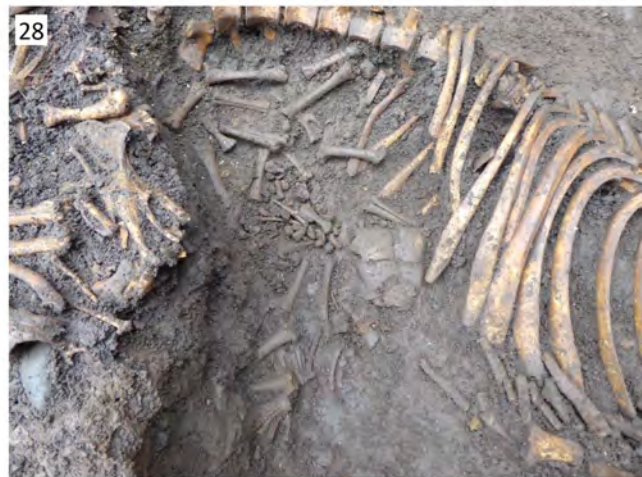
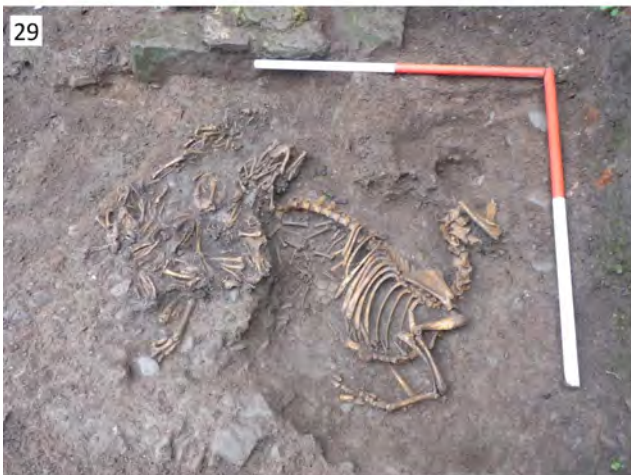
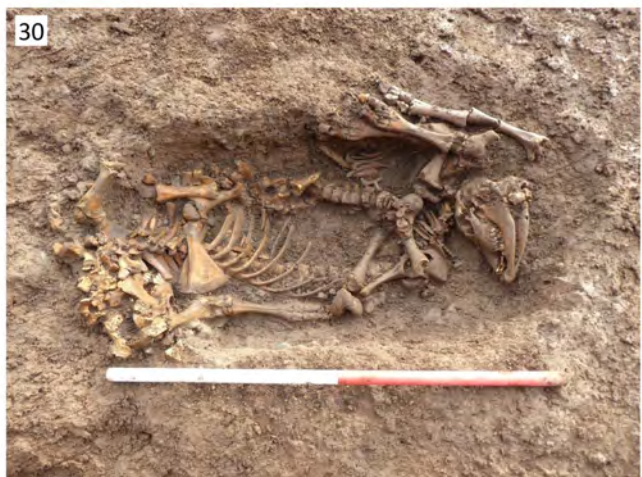
Plate 25 Buttress Foundation (3054). Facing East  
Plate 26 Buttress Foundations (3054) and Animal Burial (3027) (3075). Facing North

Plate 27 Animal Burial (3027)  
Plate 28 Animal Burial (3027) with Neonates (3075)  
Plate 29 Animal Burial (3027) (3075) (3030)  
Plate 30 Double Animal Burial (3051) (3052) [3053]. Facing

A larger burial cut lay to 1m north of the pig burial and contained a Mammal that had possibly died giving birth (3027), due to multiple skeletons of neo-nates in the abdomen and one of these in the pelvic area, (3075). This lay within a sub-square – sub-rounded cut, filled by mid to dark brown fine stony silt. On top of this, covering the lower half of the mammal skeleton was a modern dumping of 6 fowl (3030). No pottery or dating evidence was present within the grave fill apart from a stray coffin nail. The burial was located up against earlier buttress foundations, (3054), medieval in date and now collapsed and 17<sup>th</sup> Century brick wall (3032). Interestingly the skeleton was sealed by a layer of small fragments of

Grave cut [3053] was oval in shape with clearly defined edges and contained a double animal burial of a calf (3052) and a pig (3051). These were laid end to end in a symmetrical fashion, the calf cranium to the east end of the grave and the pig to the west. No butchery marks or signs of disease were found on the bones. A single worked yellowish white unburnt flint was located between the calf's ribs. It is unclear if this was intentionally placed or merely residual. The grave fill comprised very compact mid orangey brown silt with small gravel stone inclusions.

At the north east corner of Trench 3 and abutting the south wall of the Church, buttress foundations were uncovered relating to an earlier phase of the Church. This feature measures 1.10m Square and comprise large pieces of flat, red subangular edged sandstones and one Grinshill sandstone. Bonding material in the form of yellowish white lime-based mortar was lying between and over the stones. The depth of the foundation was not ascertained and left in-situ. The buttress would have obscured the current window of the church at the east end, therefore, must relate to an earlier phase before the current window was inserted, unless it was of a much lower build than the buttress at the west end depicted in paintings in the 1700's. There are aligning anomalies in the south wall at this point (3070), likely related to alterations connected with the buttress.

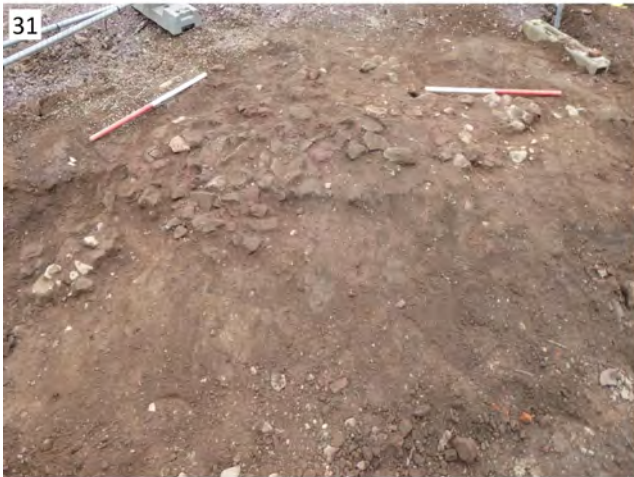
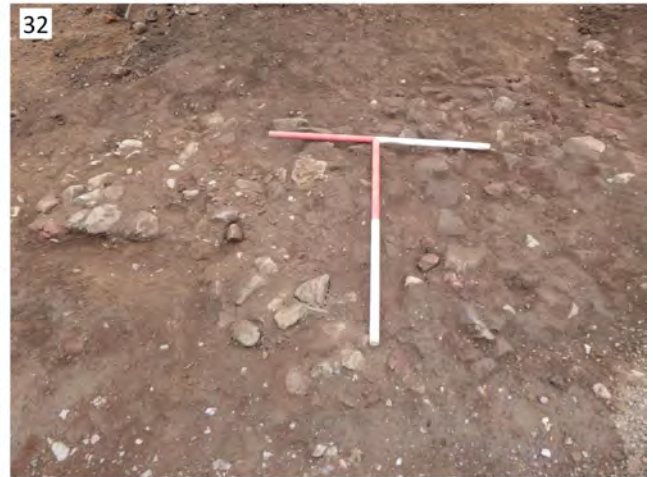
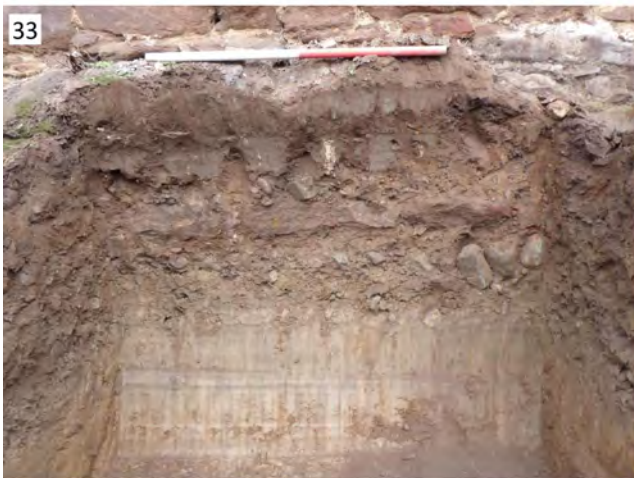
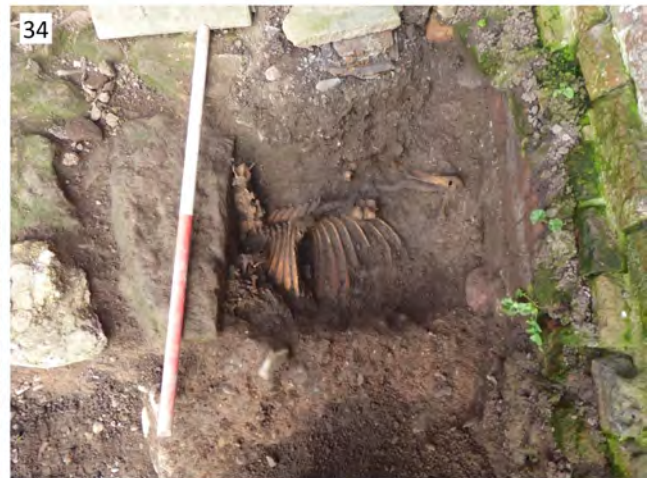
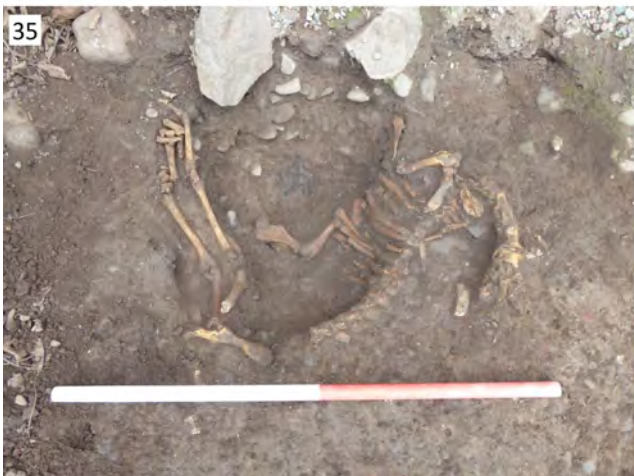
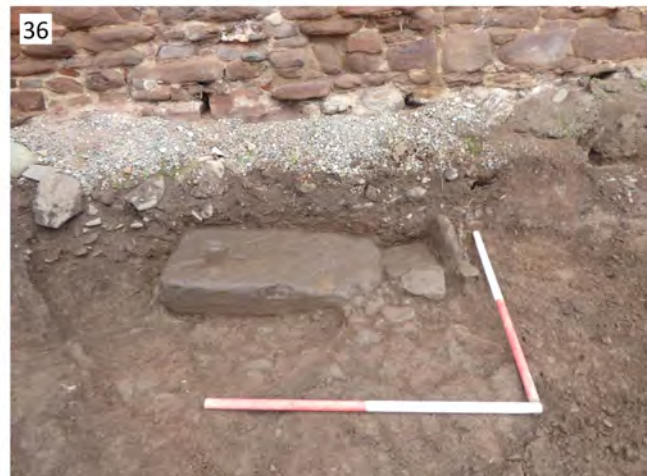
Plate 31 Rubble Spread (3047). Facing North

Plate 32 Rubble Spread (3047). Facing North

Plate 33 Foundations of South Wall of Church (3067) (3068) (3069). Facing North

Plate 35 Animal Burial (3015). Facing North

Plate 36 hold Stones (3058) (3061) and French Drain (3053). Facing North

This feature comprises a dense irregular spread of small angular red sandstones, ranging between 0.10m – 0.30m in size. Occasional pale whitish grey smooth stones are present within the deposit, as are several Grinshill sandstones. The area measures approximately 2.5m East to West, 2.5m north to south. It is heavily disturbed to the Southern edge by a burnt deposit (3080) that extends into the trench bulk. The deposit was not excavated at this time. To the north eastern edge, the stones form a right angle and appeared to continue eastwards at some stage before being cut by later burial deposits. The western extent of the spread is cut by a modern land drain [3049]. It is likely that this rubble deposit is collapse of an earlier building, possibly such as a Porticus or southern Isle. It is also possible that it has a connection with the threshold that lies approximately 5m to the north east.

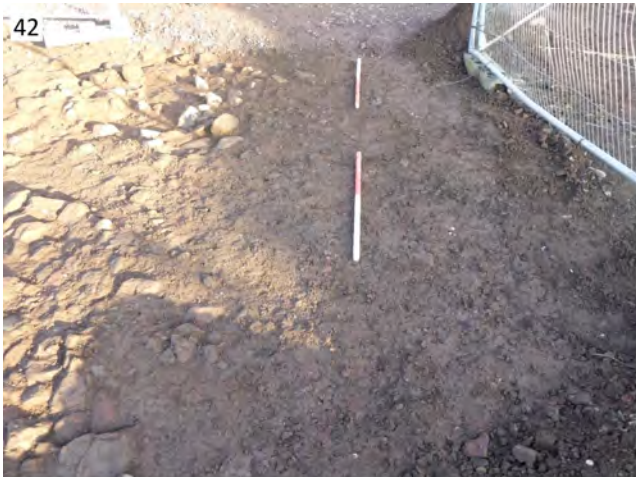
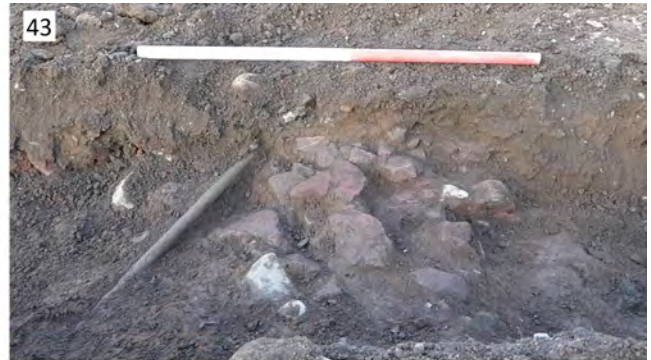
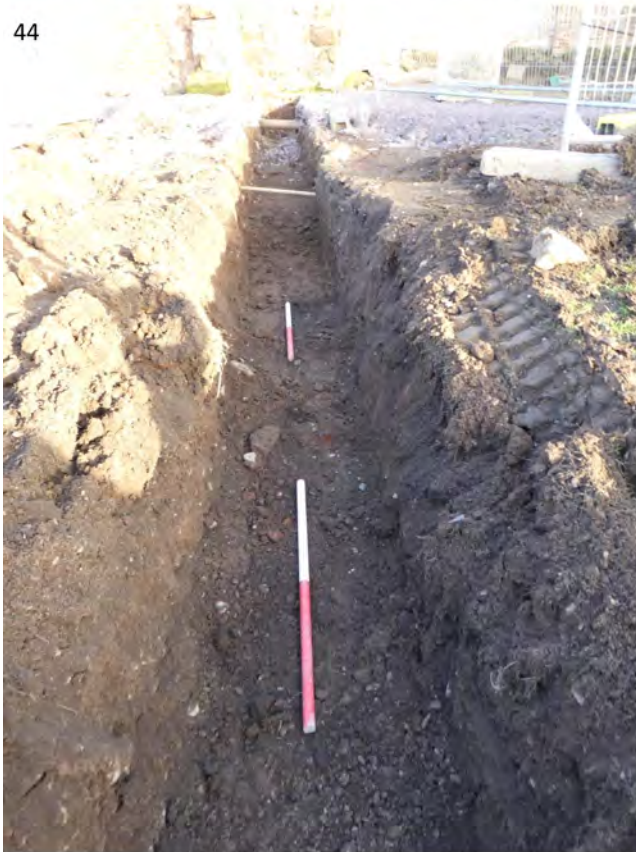
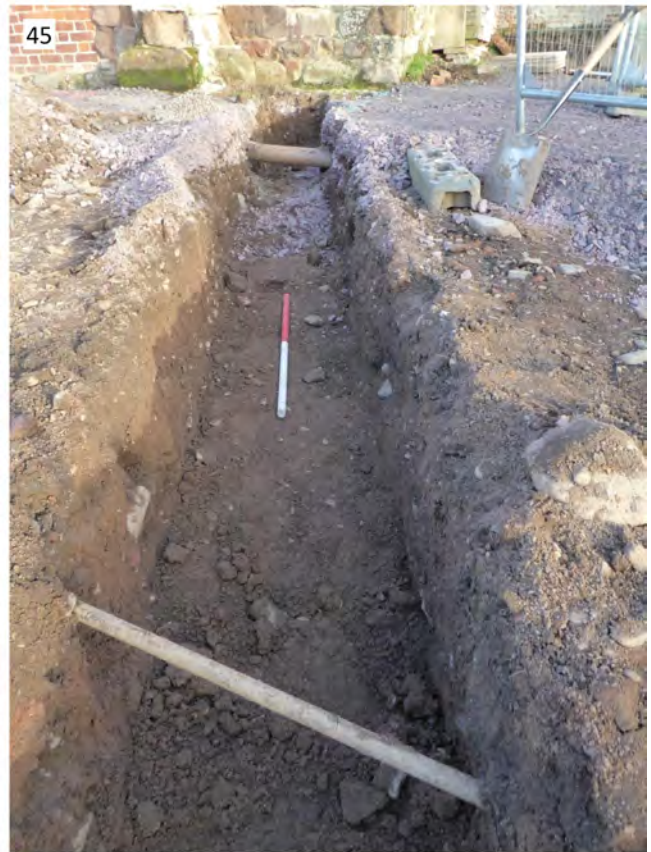
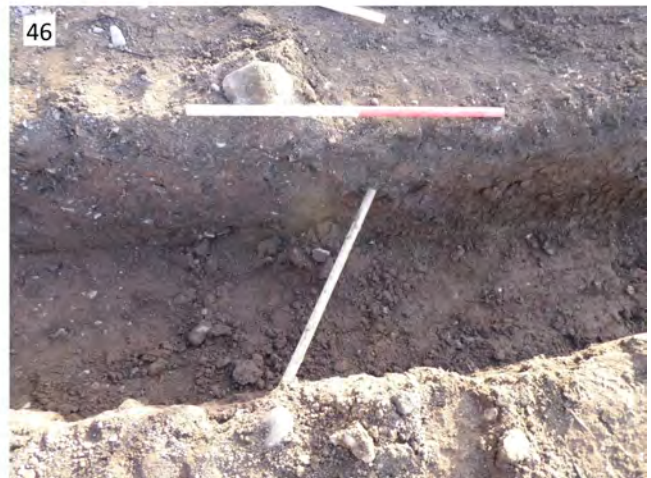
Plate 42 Route of Service Trench Pre-excavation. Facing East  
Plate 43 Service Trench Mid-Excavation Depicting Rubble (2008)  
and Electric Cable (2006)

Plate 44 Base of Excavated Service Trench. Facing East  
Plate 41 Base of Service Trench. Facing West  
Plate 46 North Facing Section of Service Trench and Electric  
Cable

removed due to associated works. Topsoil depth varied across the trench with a maximum depth of 0.28m. Subsoil depth averaged 0.12m. A rubble deposit (2003) was encountered around an electric cable [2007] running through the trench 0.14m below stripped ground surface, aligned north south. The rubble is likely associated with collapse from the earlier phases of Church walling uncovered 1.2m to the North. although could possibly represent the ephemeral remains of further foundations. The rubble showed no evidence of bonding material and was not visible in section. This was carefully examined, hand cleaned and recorded. This feature had been heavily disturbed by the cut of the electric pipe. The depth of the rubble was 0.15m max. It was then removed to continue the trench.

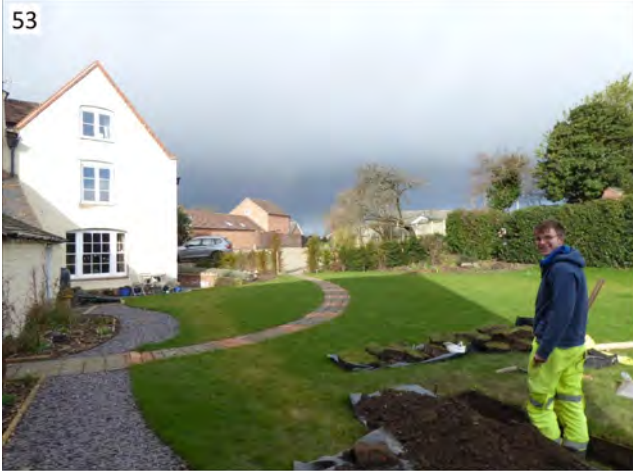
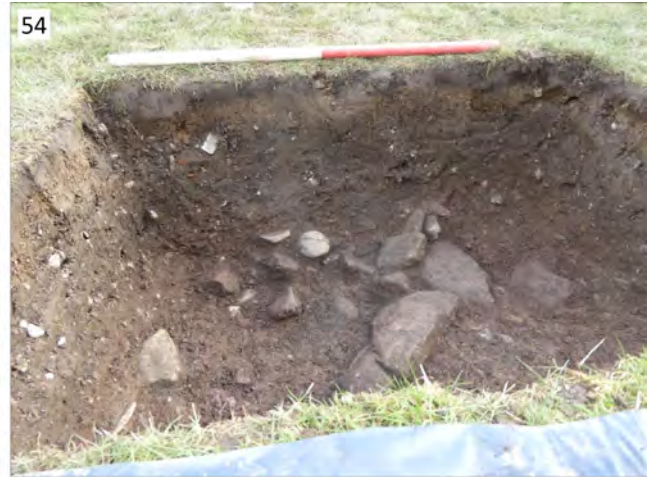
Plate 53 Test Pit Facing North Depicting Farmhouse  
Plate 54 West Facing Section of Test Pit. Foundations (4004)  
Plate 55 Example of stonework from Church in neighbouring garden.

At 0.44m below ground level, foundation deposits (4004) were encountered. These comprised several large, red sandstones, Grinshill sandstones and another paler type of sandstone on the southern edge with a rubble core to the north. This feature was within a yellowish-brown silt deposit. Numerous fragments of plaster and possibly bonding material were present, but not visible directly between the stones. Although this was a very small area that was examined, the stones visible above ground appeared to be forming a semi-circular curve running south east and deposits were continuing in north, south, east and west into the trench bulk. This foundation aligns to the position of the current Church wall to the west and is likely to represent an earlier phase of the Church, possibly an Apse. Further stones were ascertained to continue below this depth but not excavated at this time. The foundations uncovered
